MONOGRAPH

A Mobile Laboratory for UHF and VHF Television Surveys

E. W. TAYLOR, M.A.

L. C. MUNN

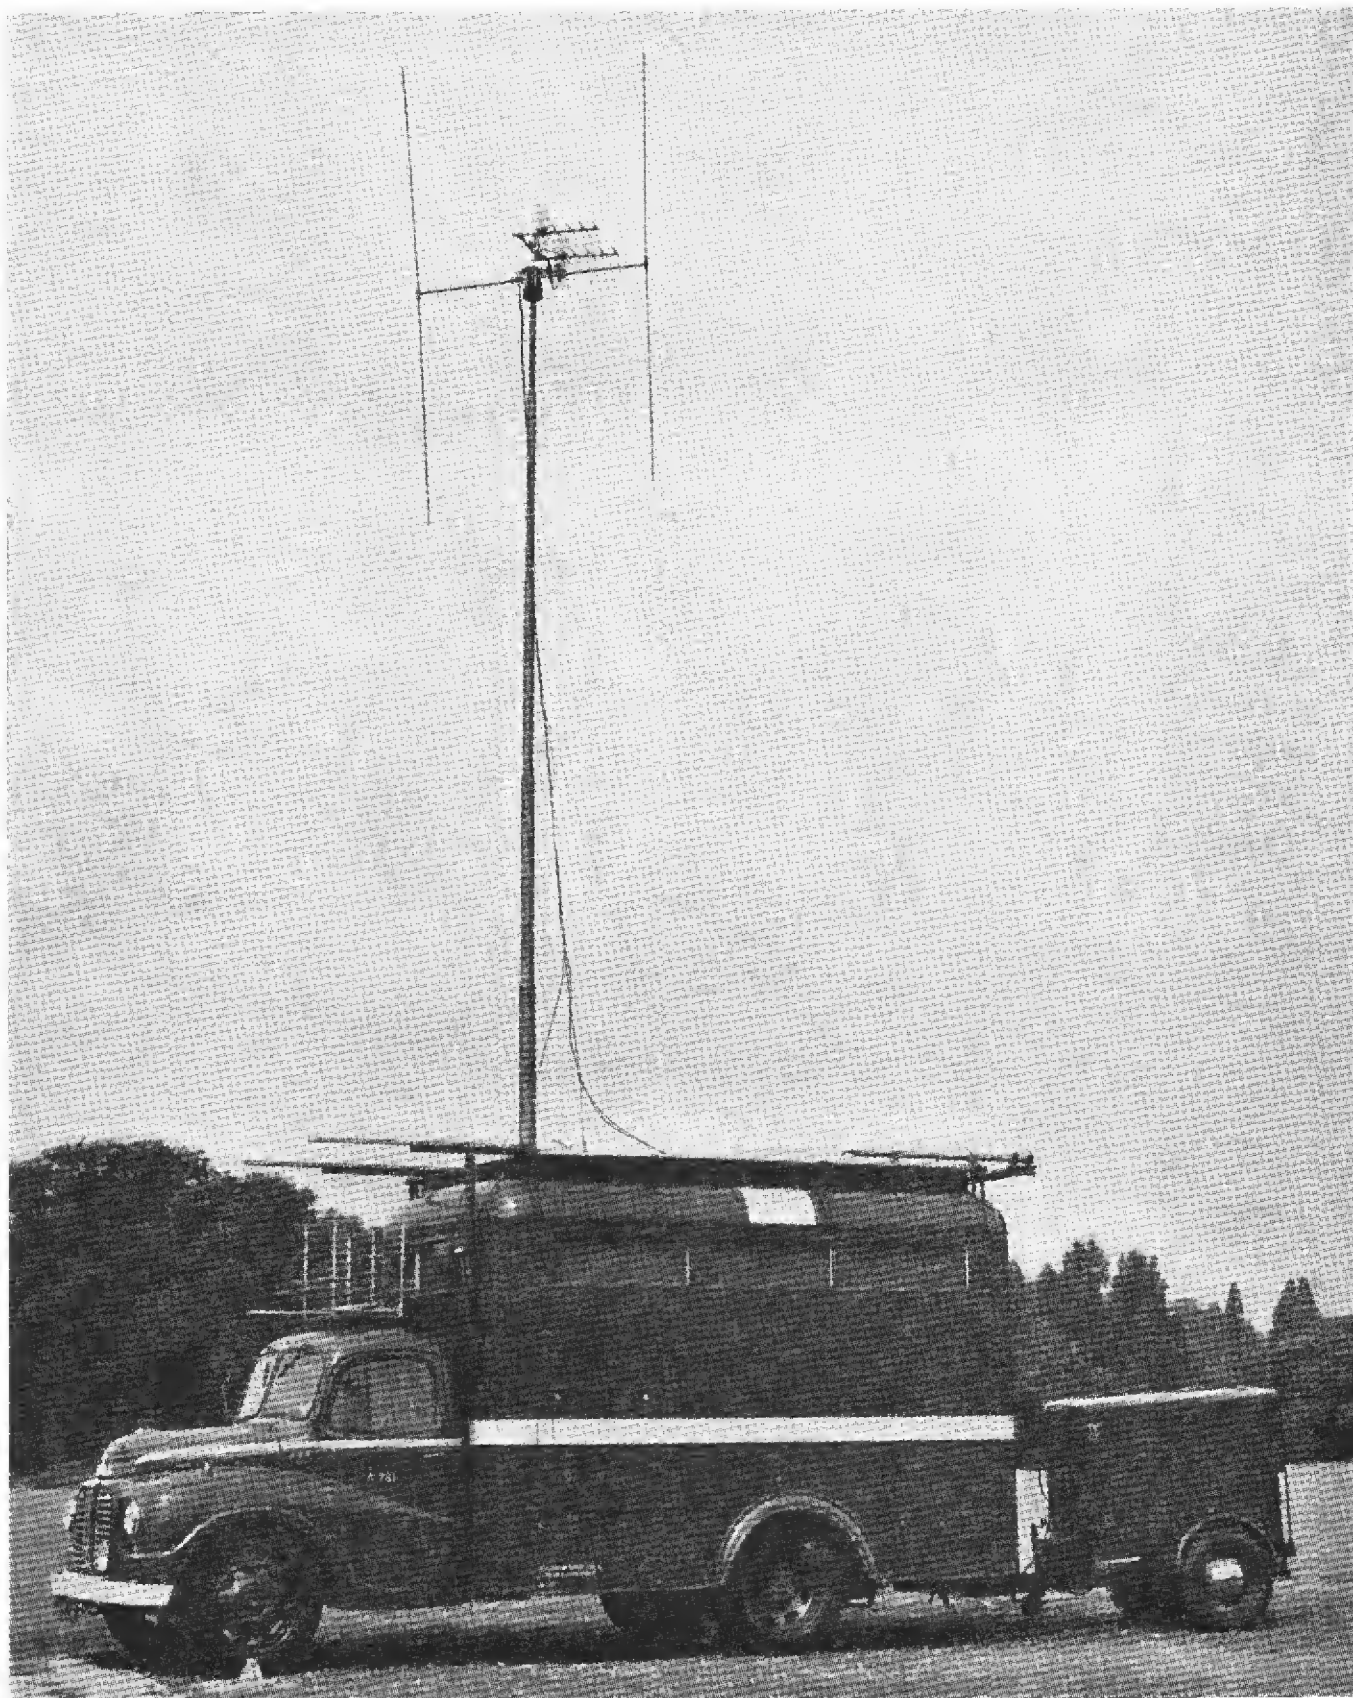
Fig. 1 — The mobile laboratory equipped for the Series B tests

members; these can be seen projecting over the driver's cab in Fig. 1.

sites all requiring the same array. When not in use the one-array and four-array aerials were carried on the roof of the driver's cab (these can be seen in Fig. 1), and the two-array aerial was carried inside the vehicle.

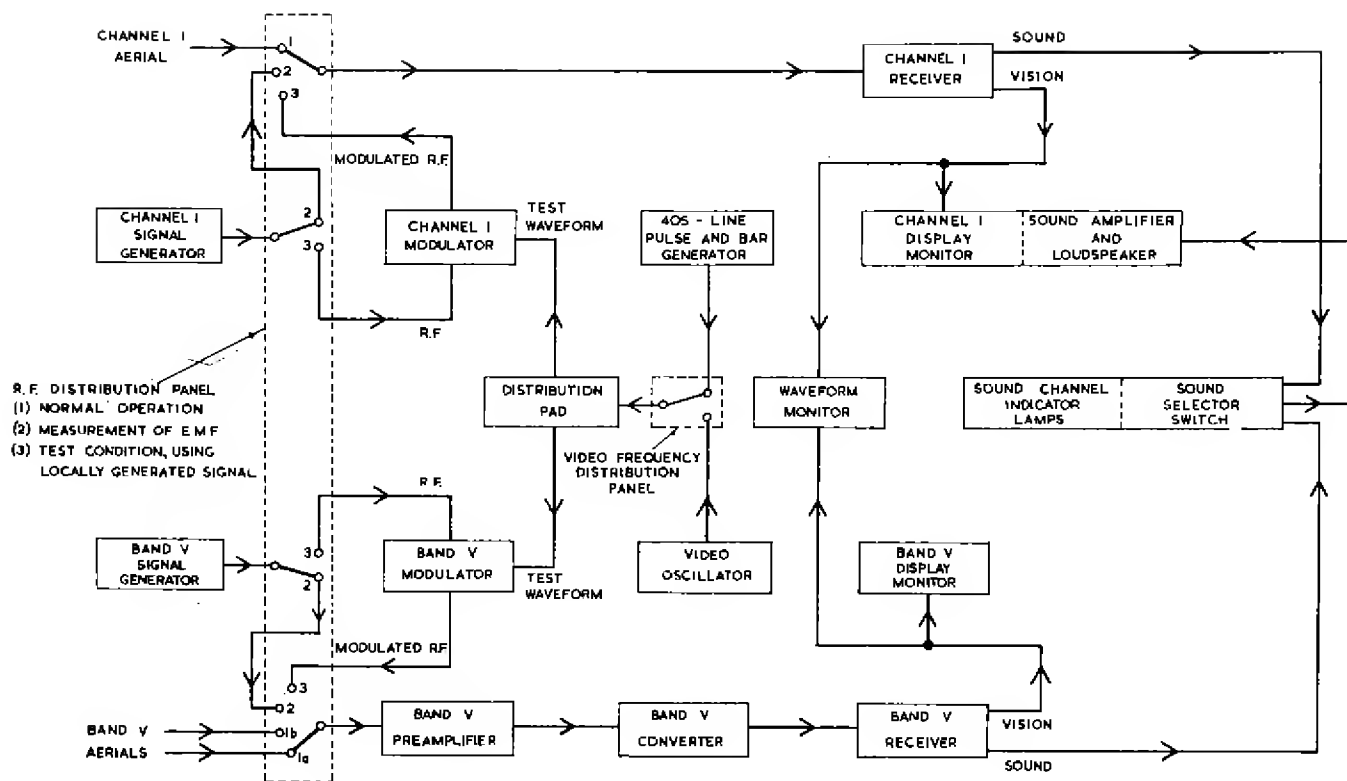
Fig. 2 — Block schematic of equipment used for the Series A tests

In both the above diagrams the interconnections normally used on the distribution panels are represented as switches; other connections were available if required

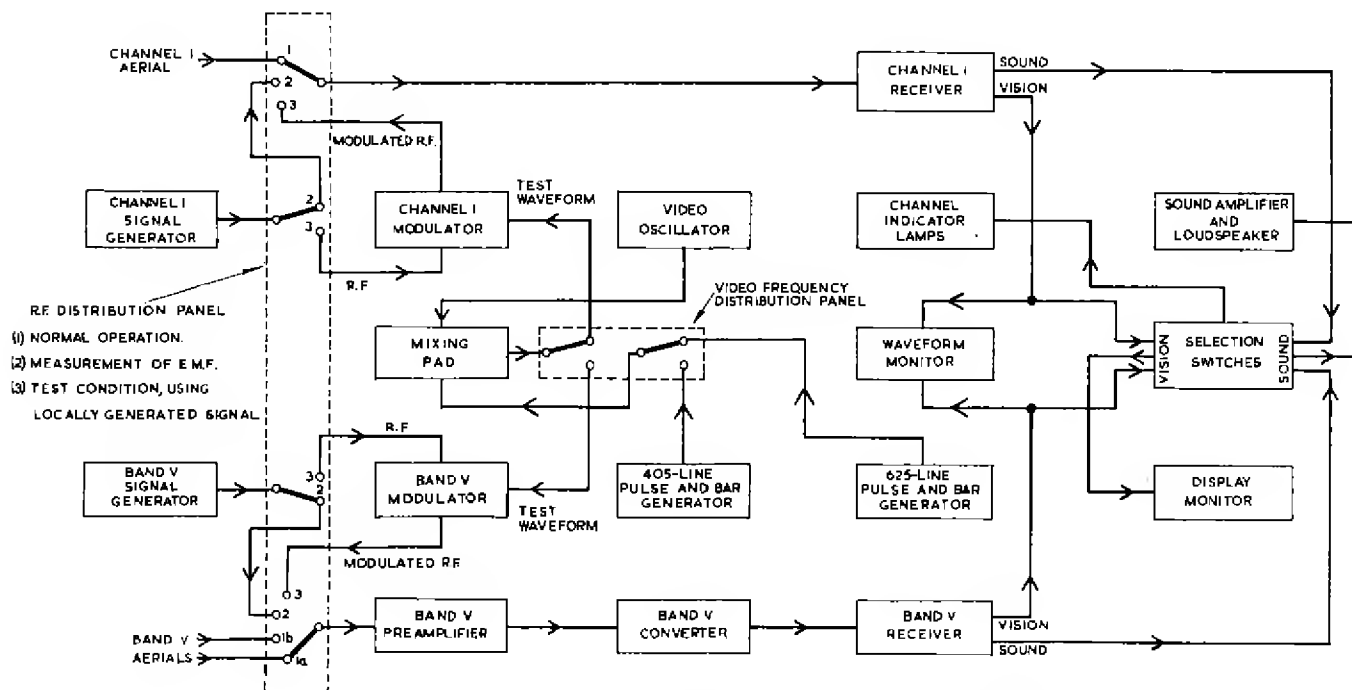
Fig. 3 — Block schematic of equipment used for the Series B tests

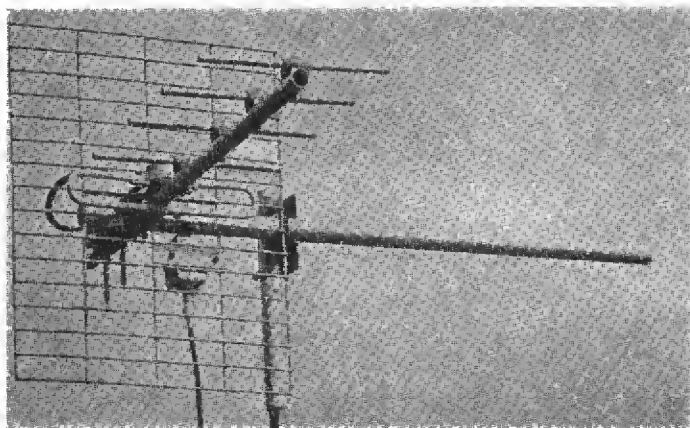
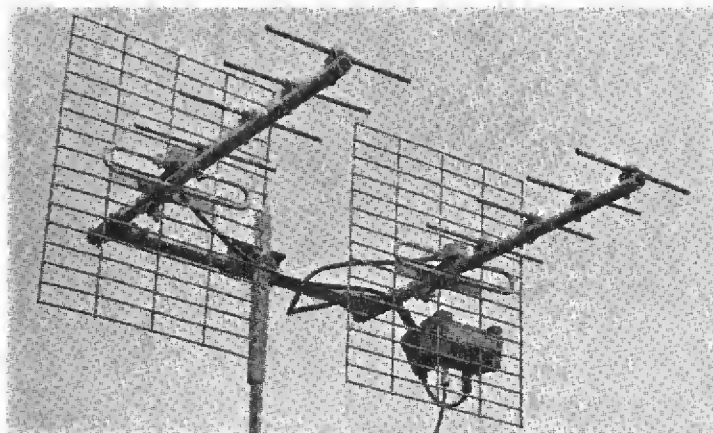
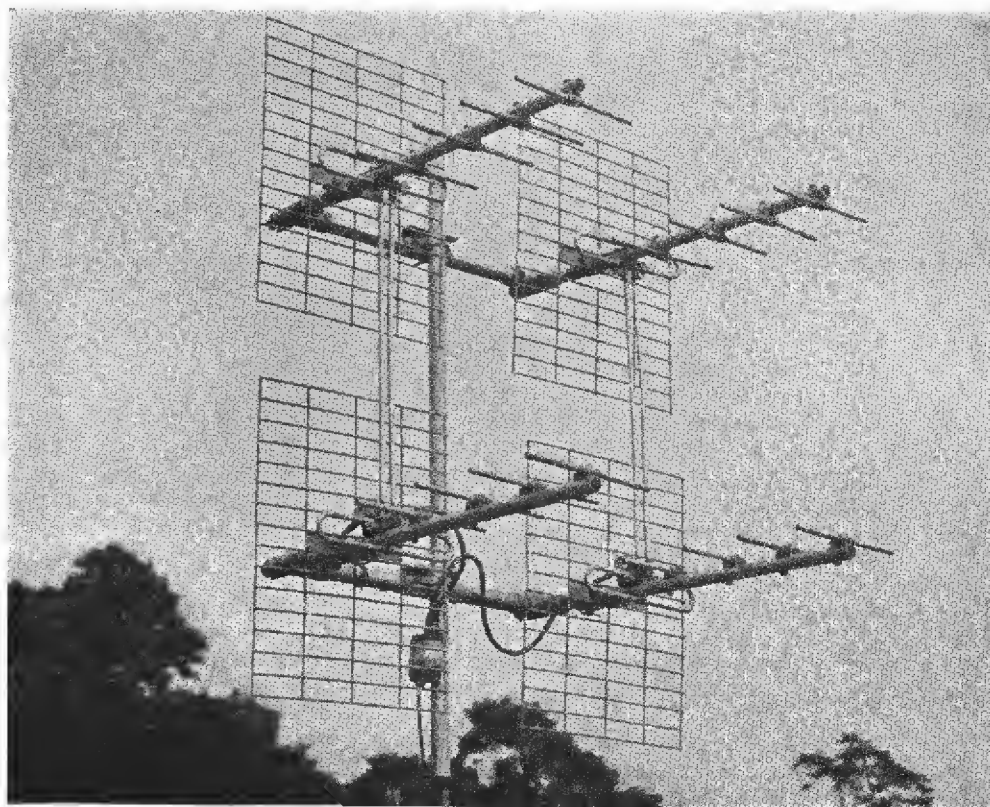
(a) Low gain

(b) Medium gain

(c) high gain

Fig. 4 — Band V aerals

During the survey a very large range of field strengths was encountered and three aerials of different gains were therefore carried. The aerials were all based on a Yagi array consisting of four directors, a folded dipole, and a wire-mesh reflector. Assemblies comprising one array (Fig. 4(a)), two arrays (Fig. 4(b)), and four arrays (Fig. 4(c)) provided aerials with low, medium, and high gains respectively. The aerial chosen for use at a particular site (during the Series A tests) was the least complicated array that would produce a satisfactory picture. Usually the choice was influenced by the necessity of having sufficient aerial gain to provide an adequate input to the receiving chain and so ensure a good signal-to-noise ratio, but sometimes an aerial of higher gain than was necessitated by this consideration had to be used to reduce unwanted echoes. For the Series B tests the aerial used at each site was the same as had been previously used for the Series A tests, in order to make the two series of tests more directly comparable.

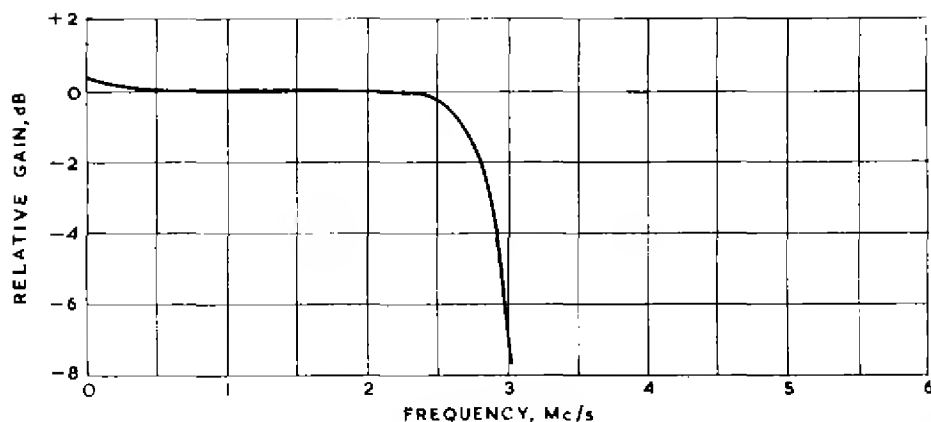
Fig. 5 — Overall modulation/frequency characteristic of Band V receiving chain—Series A tests

The output of each of the receiving chains was a composite video signal: Figs. 5 and 6 show the overall modulation/frequency characteristics of the two chains.

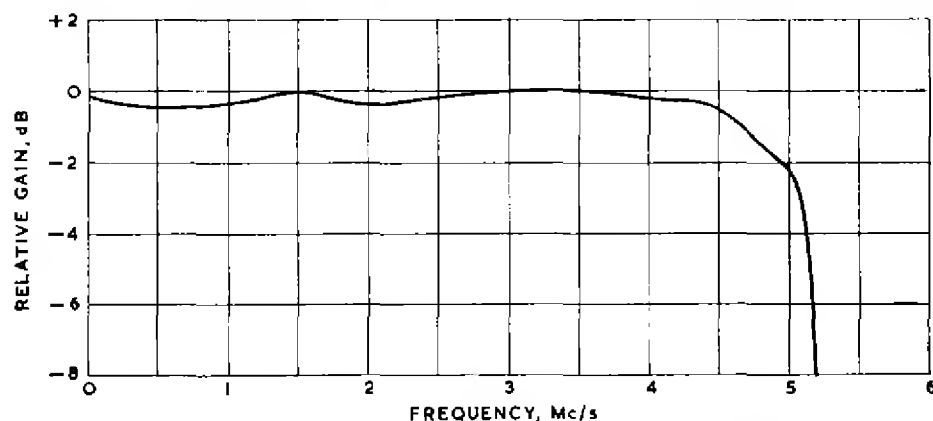
Fig. 6 — Overall modulation/frequency characteristic of Band V receiving chain—Series B tests

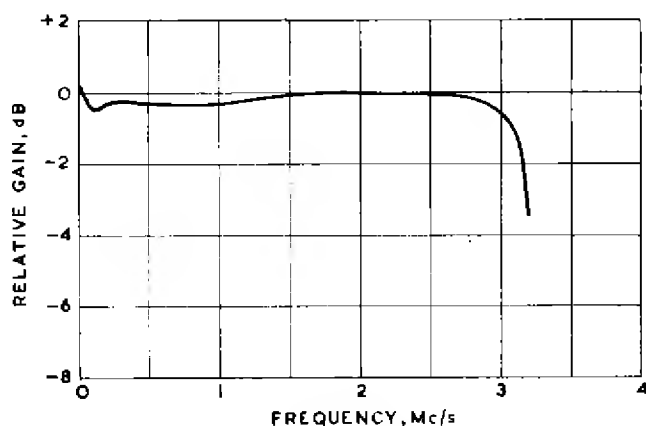
Fig. 7 — Overall modulation/frequency characteristic of Channel 1 receiver—Series A tests

Figs. 7 and 8 show the overall modulation/frequency characteristics of the 405-line receivers used for the Series A and Series B tests respectively.

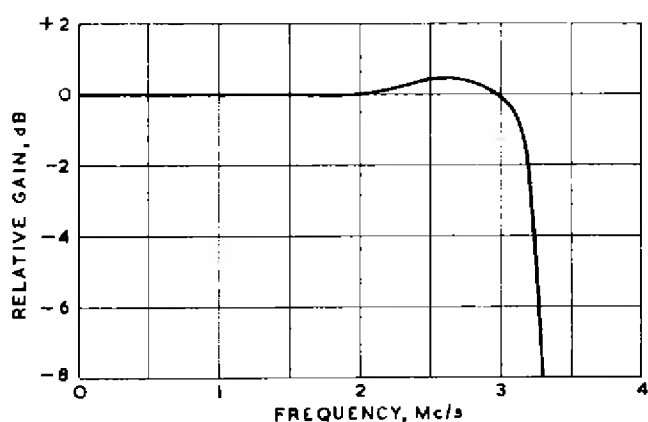
Fig. 8 — Overall modulation/frequency characteristic of Channel 1 receiver—Series B tests

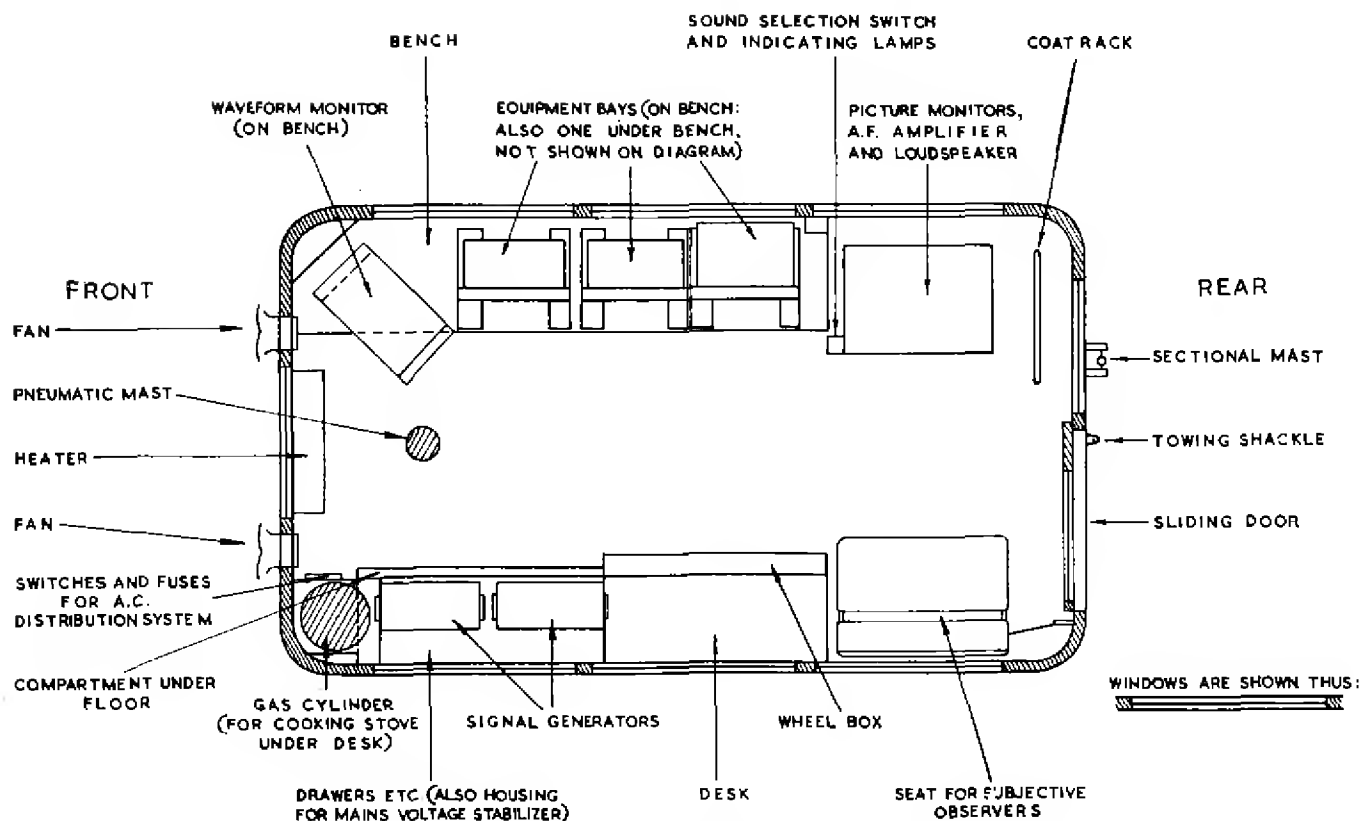
Fig. 9 — Plan of the mobile laboratory equipped for the Series A tests

The equipment layouts for the two series of tests are shown in Figs. 9 and 10. During the Series A tests the seat for the subjective viewers was near to the door of the working space of the mobile laboratory, and their work was interrupted when the door was opened: in the Series B tests their assessments could be carried out without disturbance. Figs. 11 and 12 show photographs of the interior arrangements for the Series B tests.

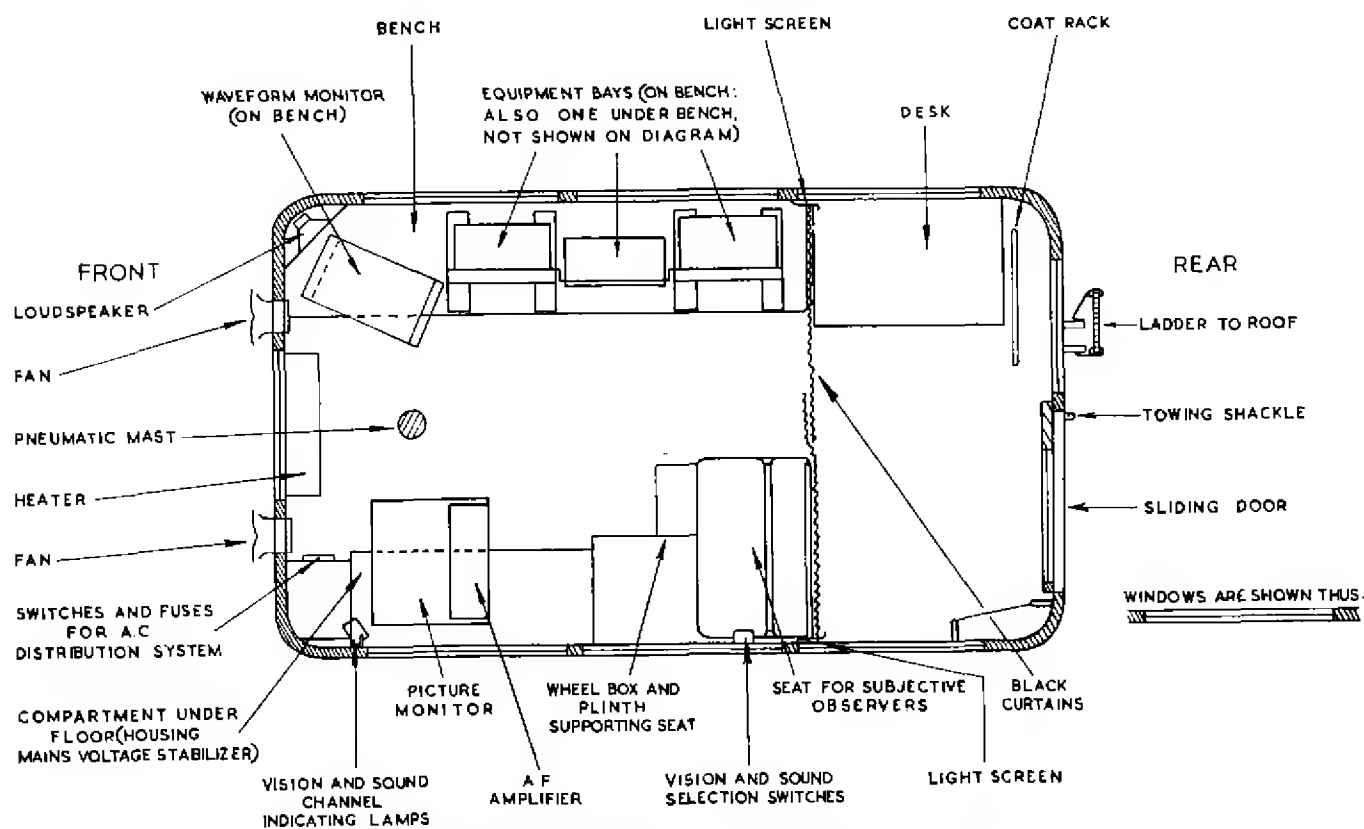
Fig. 10 — Plan of the mobile laboratory equipped for the Series B tests

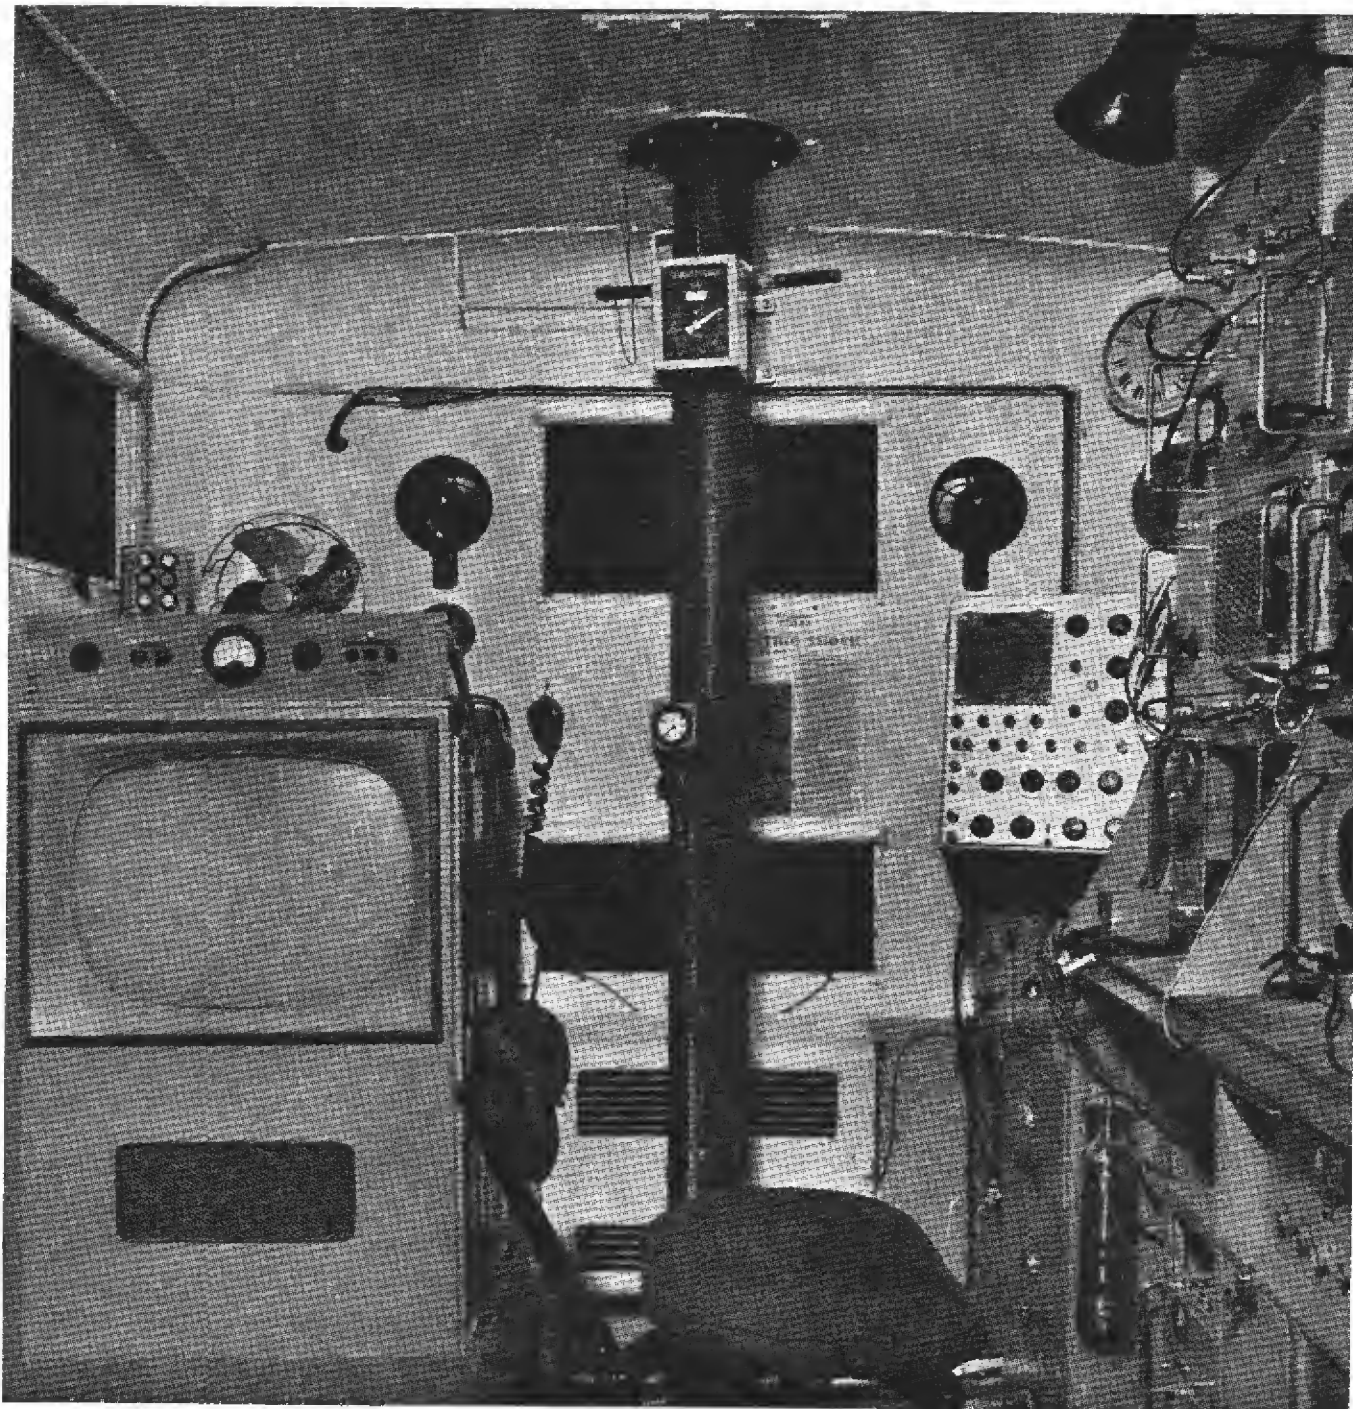
Fig. 11 — Mobile laboratory—view looking forward, showing picture monitor (left), pneumatic mast (centre), and waveform monitor (right) as arranged for Series B tests

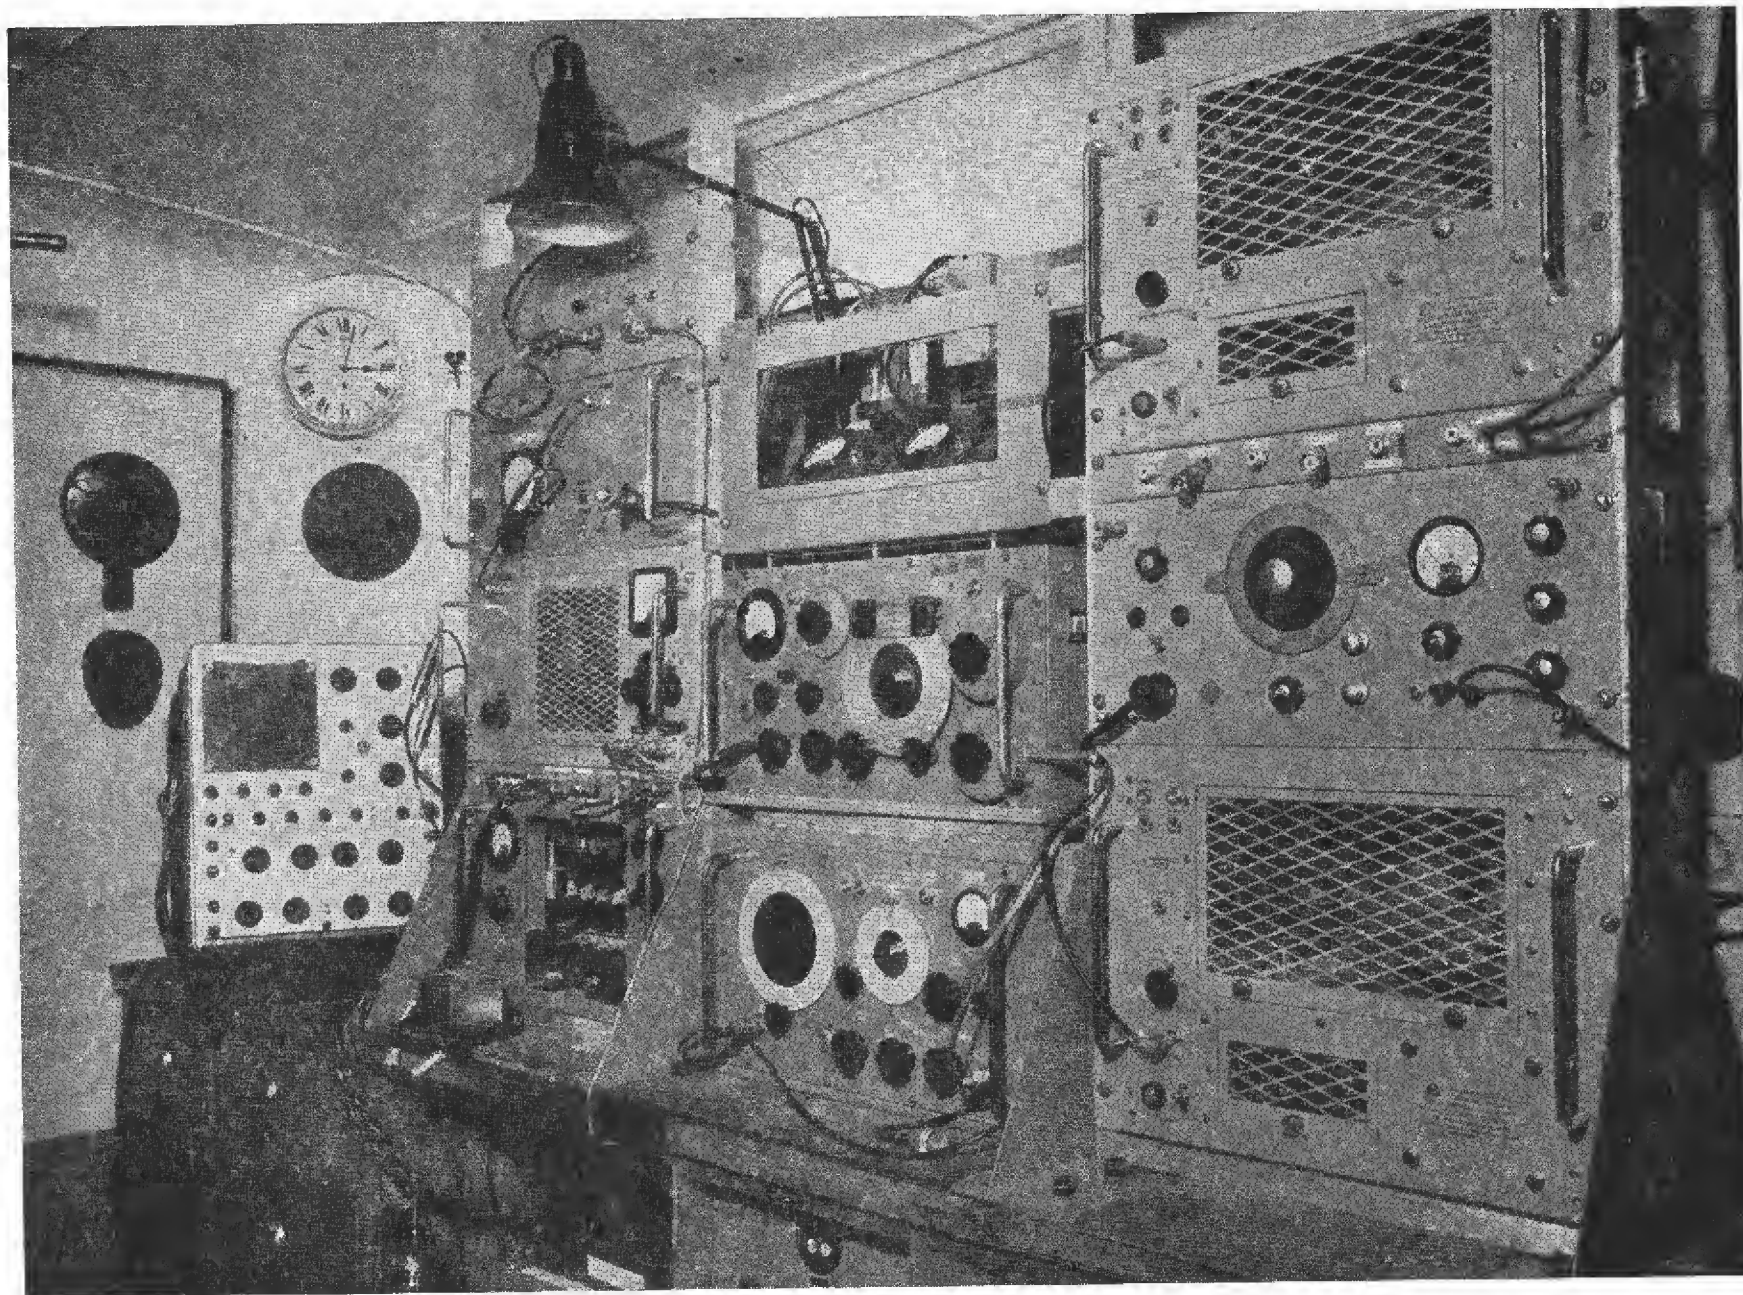
Fig. 12 — Mobile laboratory—view of receiving and test equipment as arranged for Series B tests

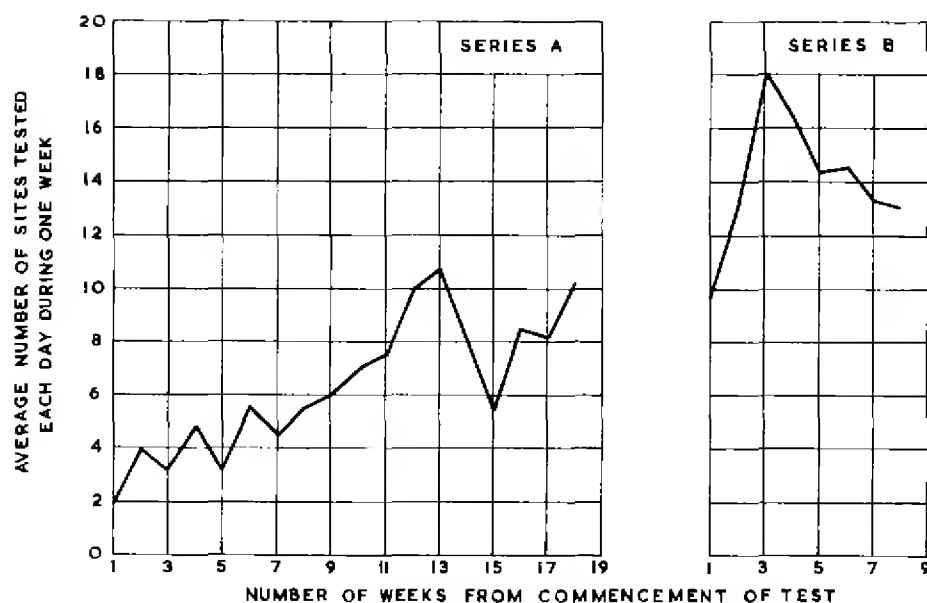
Fig. 13 — Average number of sites tested per day during each week

Series A	Series B
Average number of sites tested per day during the last six weeks of each test	8.6	15.0

Fig. 13 shows the average number of sites tested per day during each week of the survey. The steady increase during the Series A tests as operational experience was gained can be clearly seen: the increase during the Series B tests is also apparent and the steps taken to increase the speed therefore appear to have been justified. Comments from the subjective observers confirmed that their work was on the whole made much easier by the arrangements adopted for the Series B tests, but that the provision of two display monitors (as in the Series A tests) would have made the comparison of the two pictures easier, particularly in the presence of intermittent interference. As only one monitor
